# Here's the Dairy Barn that Scored "PERFECT"

Maryland Milk Producer Cashes In on Best Ideas  
of 175 Others

BY GEORGE H. DACY.

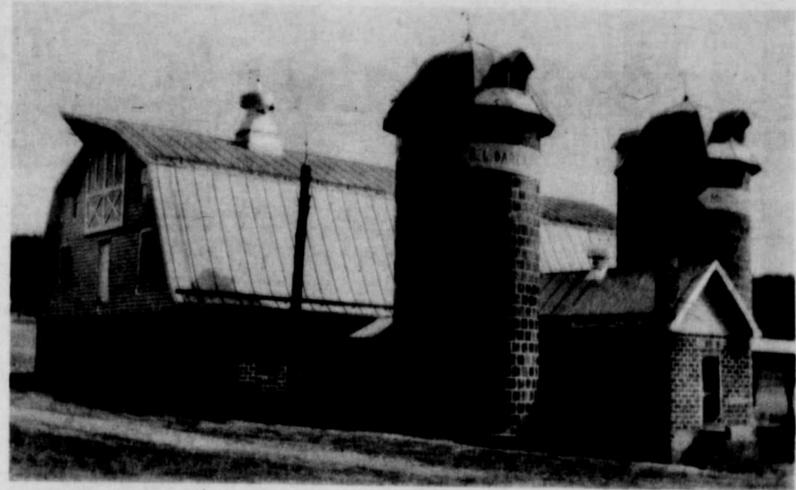
The only 100 per cent score dairy barn supplying milk to Washington, D. C. And that means perfect with a capital P.

The dairy barn is built of hollow glazed tile with a steel roof, twin tile silos, each 12 by 32 feet, concrete floors, and steel stalls, stanchions, and feed manger partitions. Maintenance costs are minimized because of the permanency of construction. The glazed tile finish is attractive externally and wearworthy. Its use facilitates keeping the interior of the stable, dairy, cooling, washup, sterilizer, and boiler rooms as clean and sani-

tary as a modern hospital. The glaze of the tile is such that in service only 0.05 of 1 per cent of moisture penetrated its surface during a 24-hour test. This guarantees a dairy barn free of moisture. And as every experienced dairyman knows, moisture in the stable is one of the most objectionable atmospheric conditions which can occur.

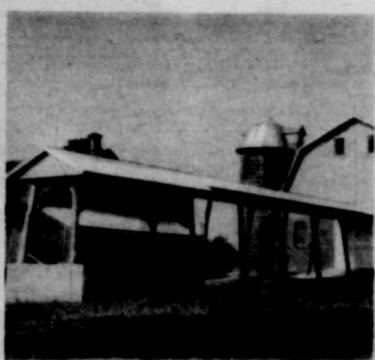
Pictured here is The Mountain Top Farm dairy barn's manure disposal system.

The litter carrier system is protected by a canopy hood with a metal roof which extends from the barn to the concrete storage pit. The pit, 22 by 10 by 4 1-2 feet in size, is large enough to accommodate the refuse which accumulates during bad weather when conditions prohibit hauling the litter to the field. Concrete sidewalks connect all farm buildings.
