THE 27TH STREET STATION OF THE N

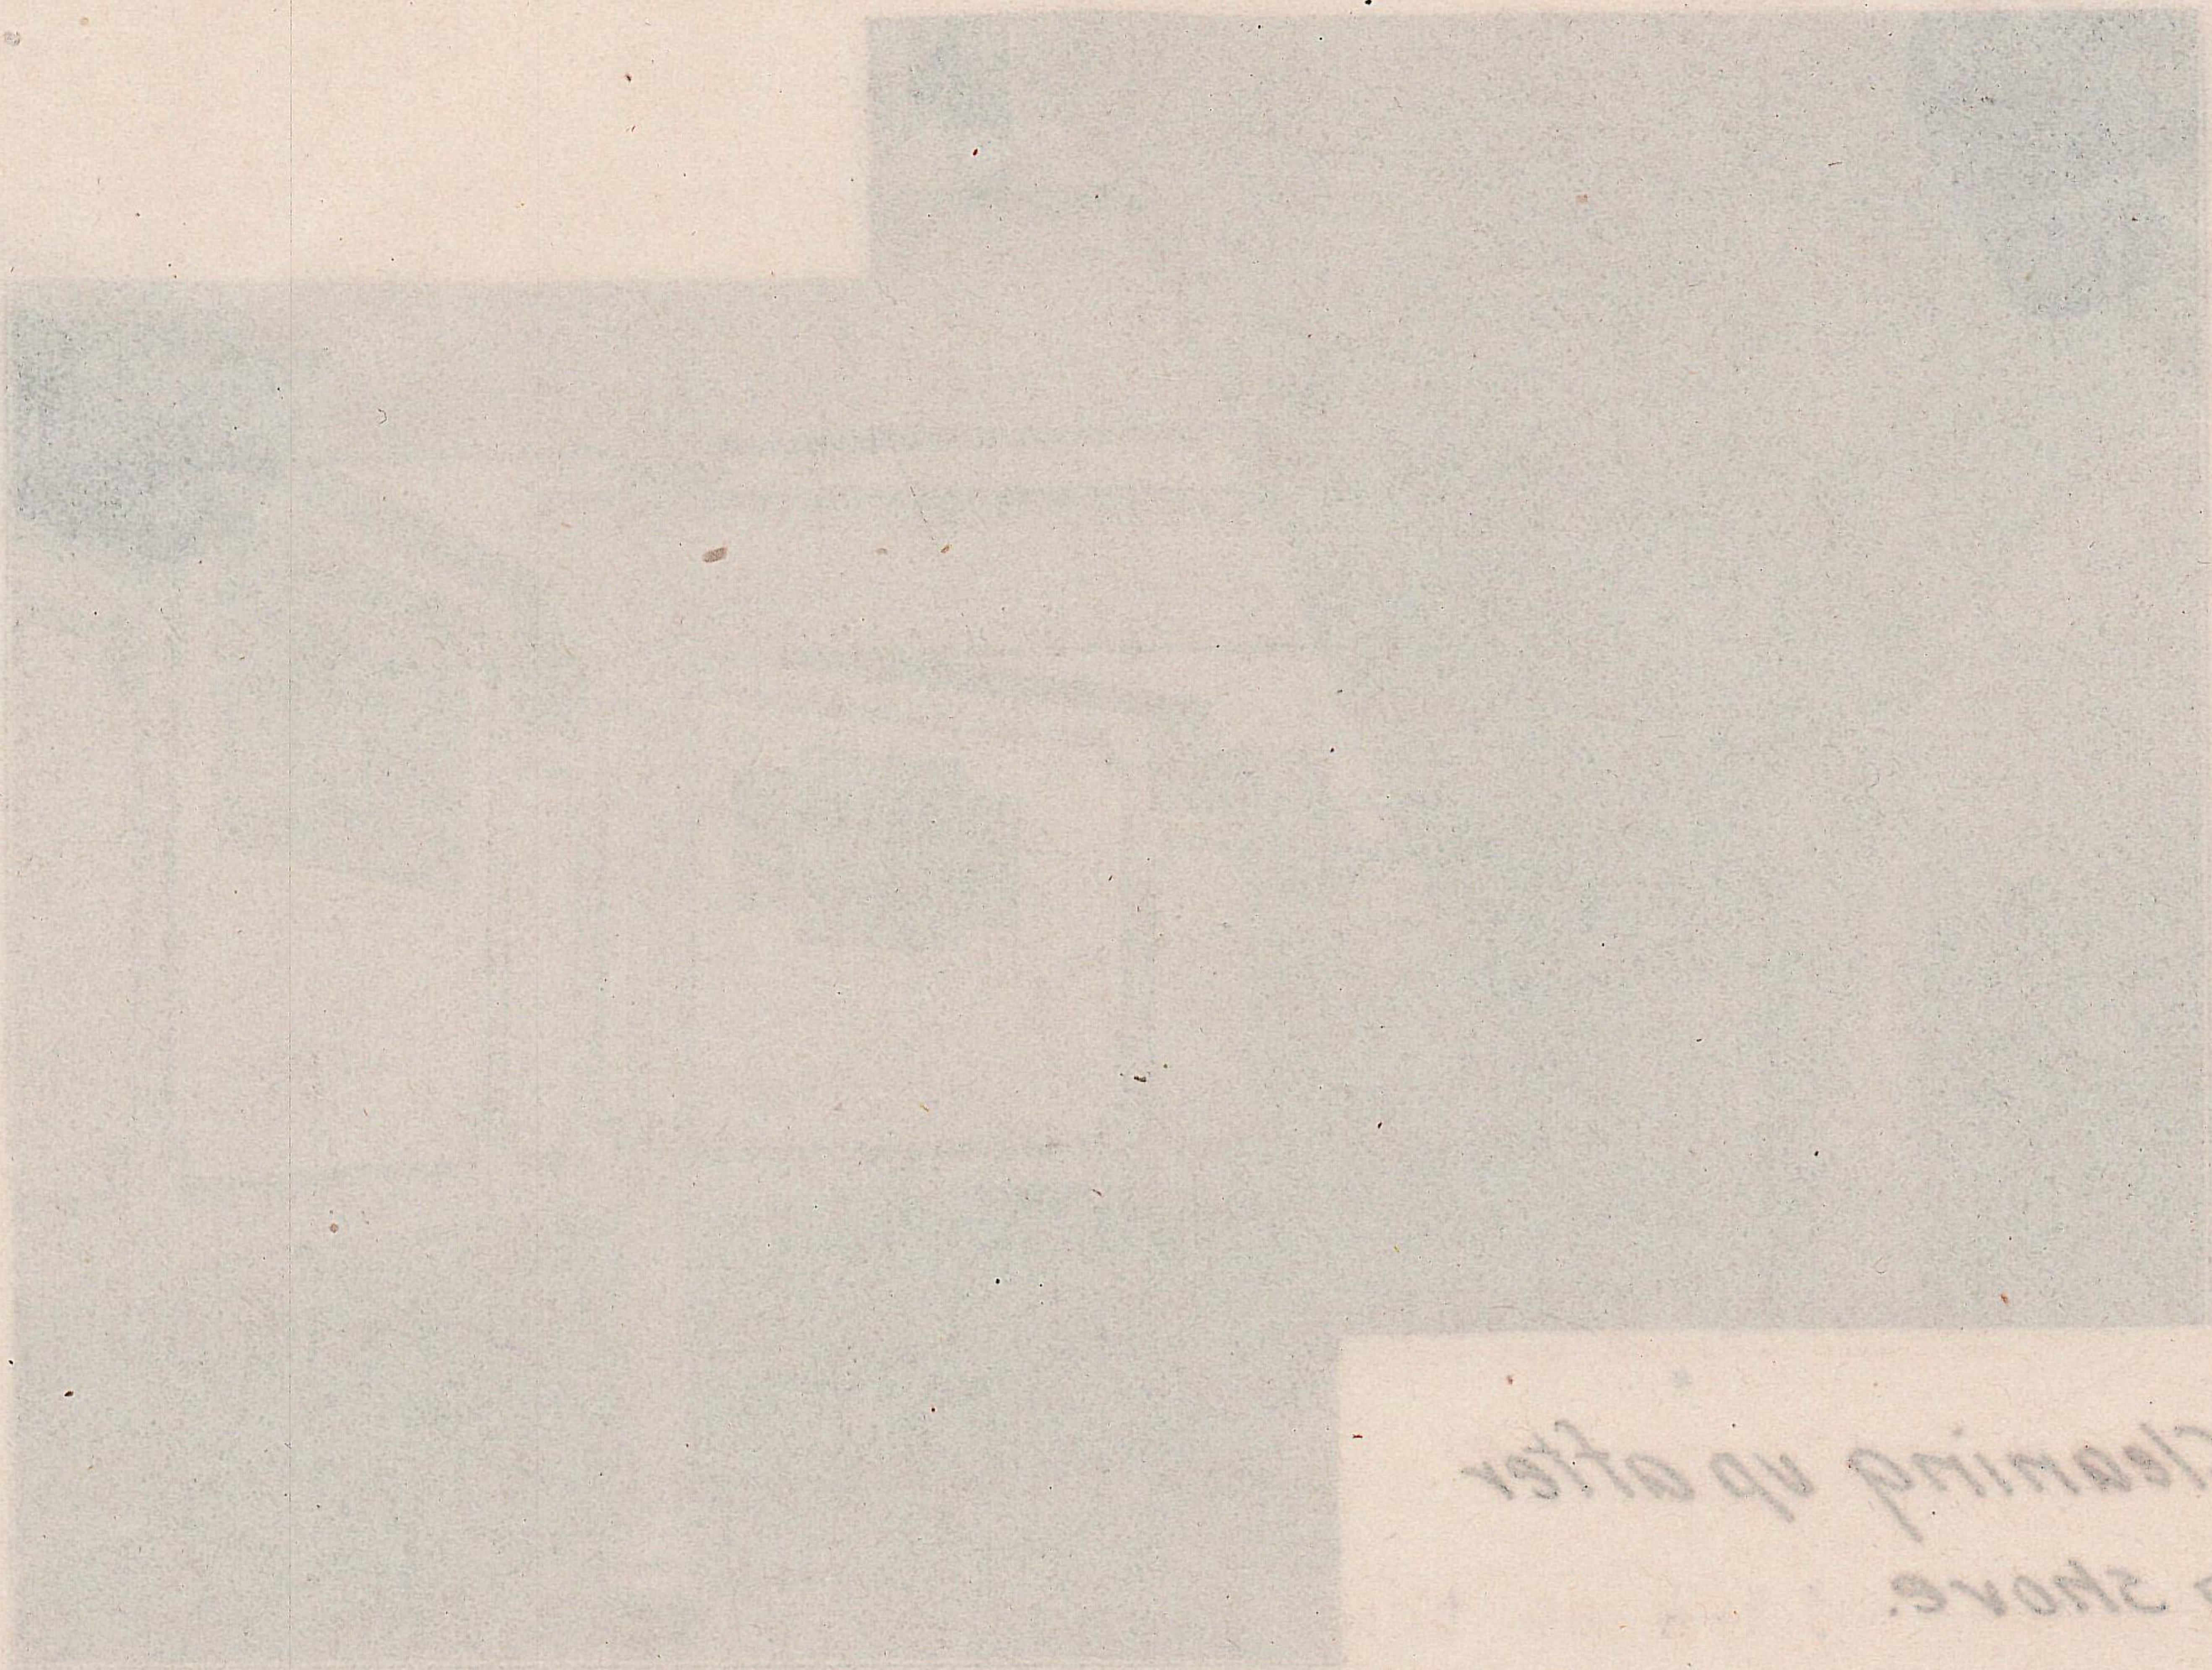
Cleaning up after
a shove.

Erecting platform in background.
North Tube.

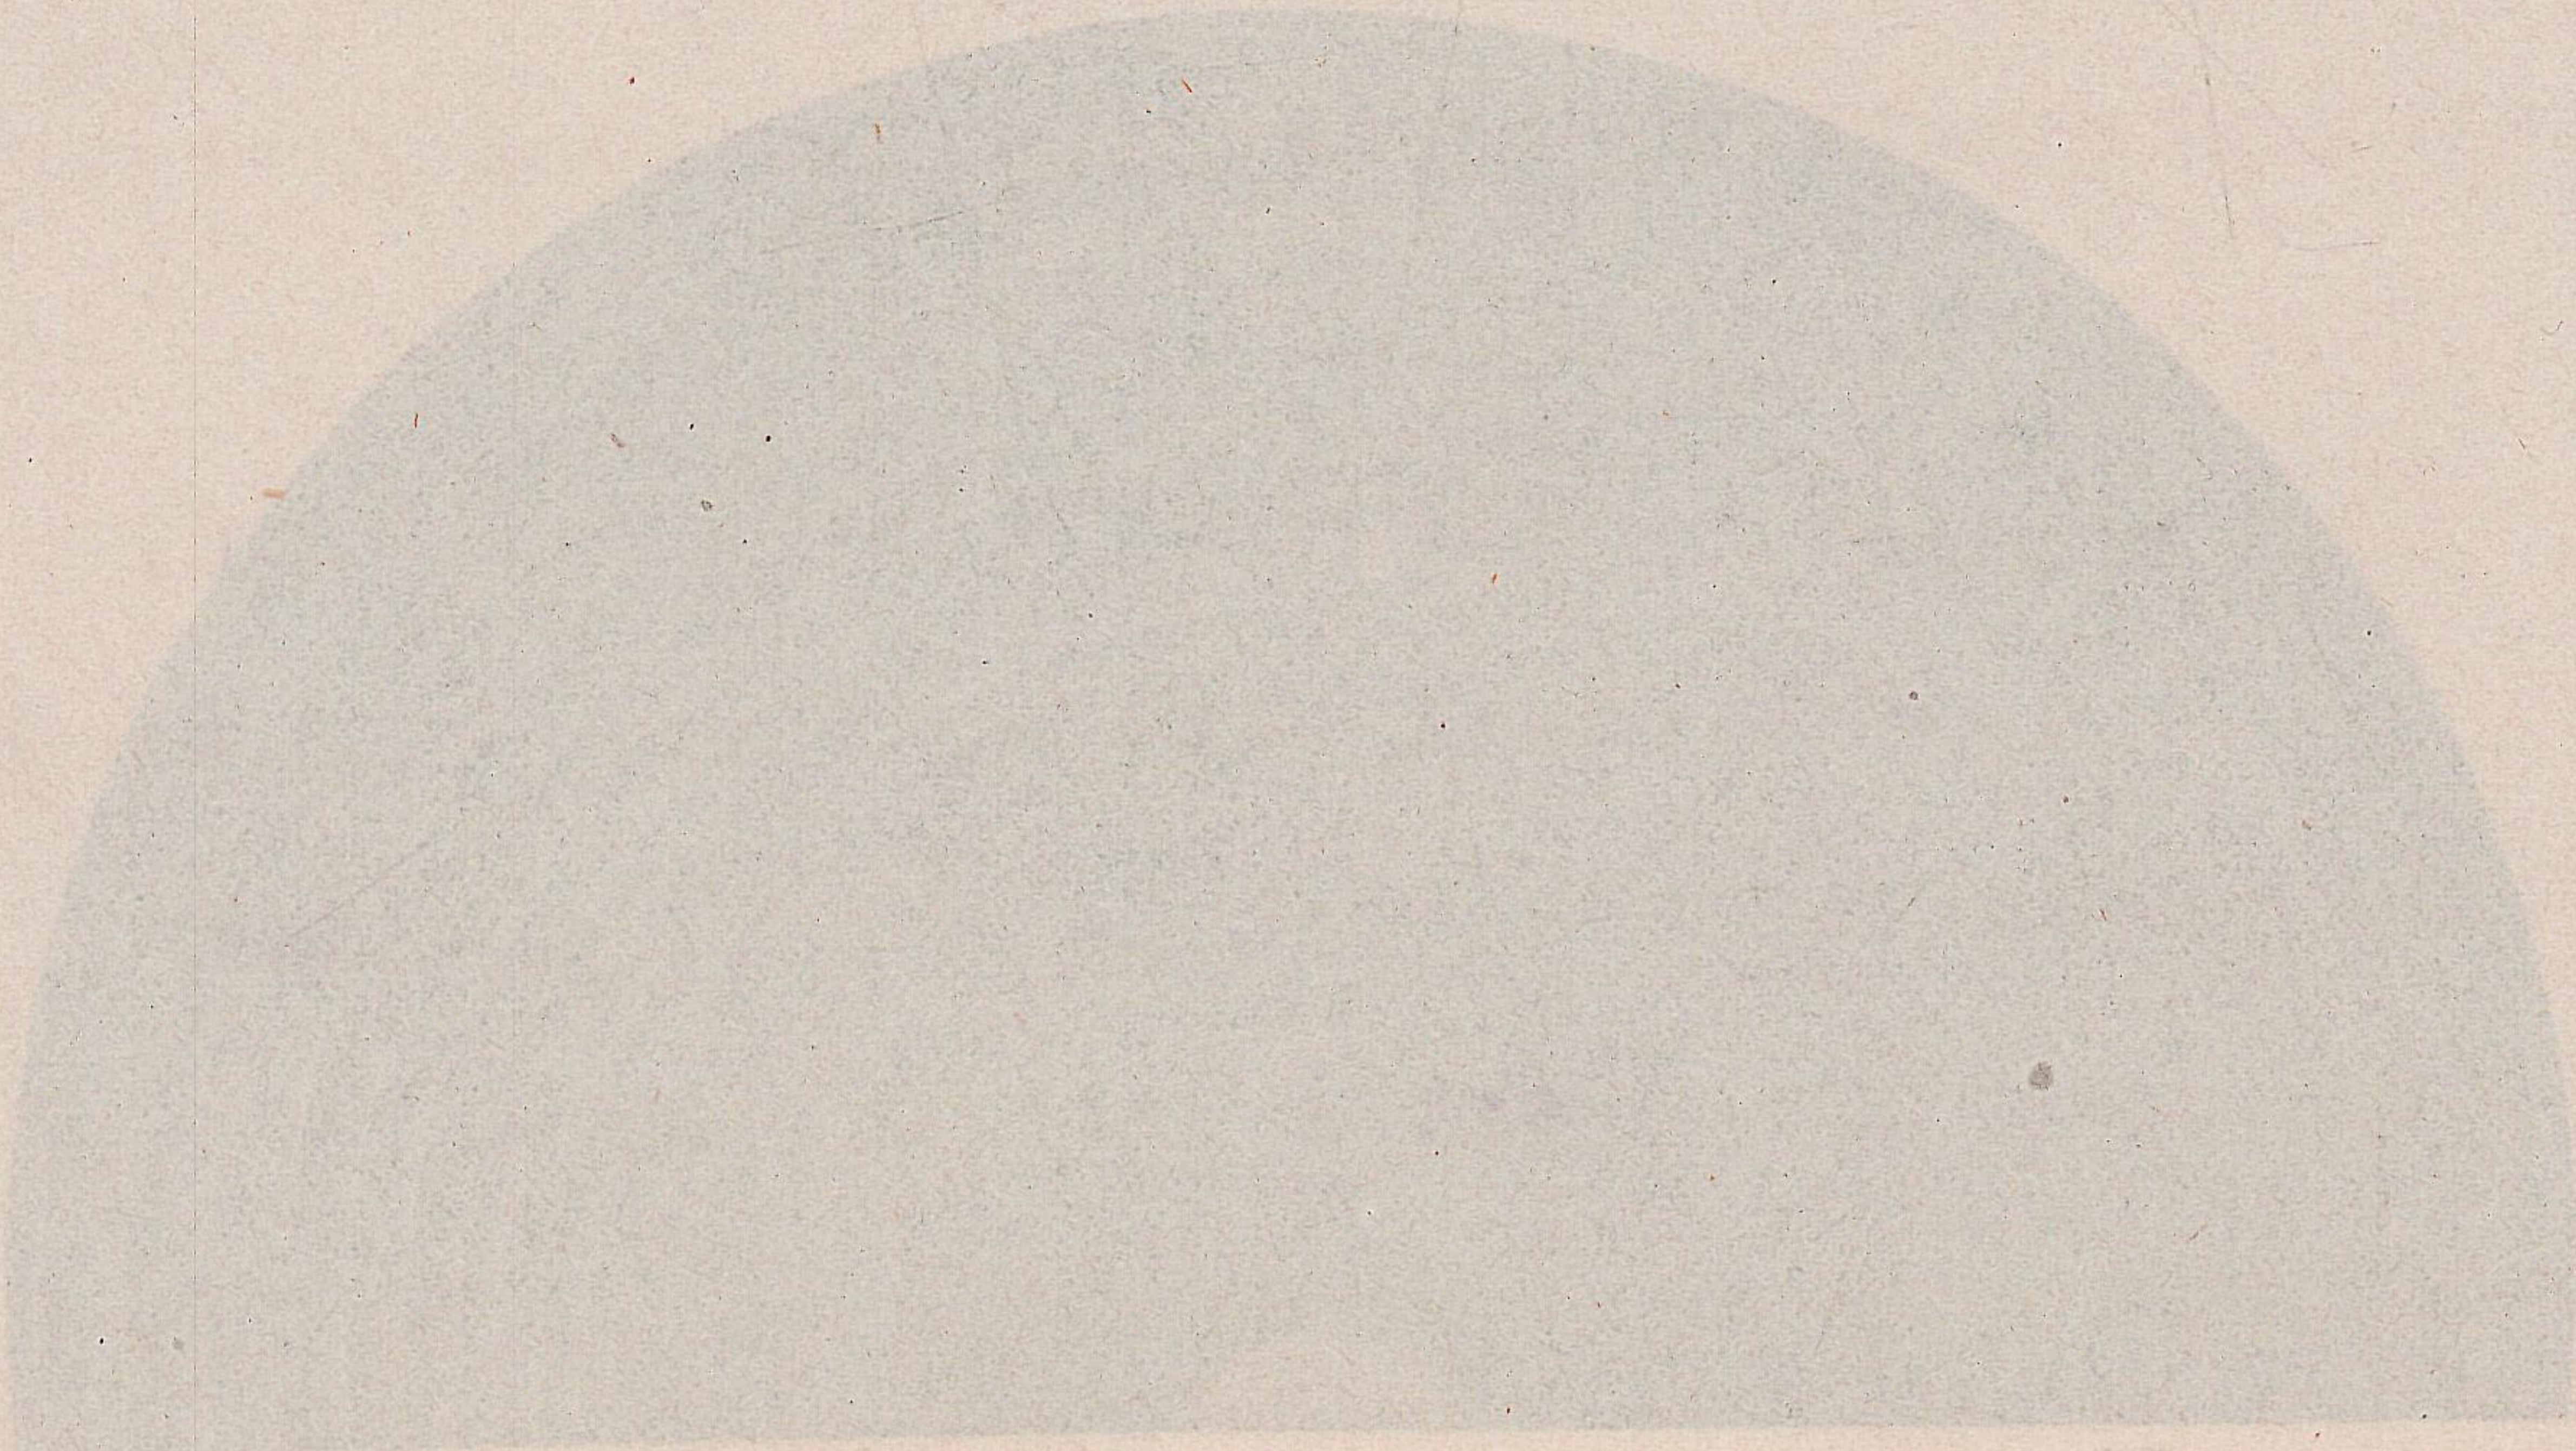
Shield partly in ledge of rock.
Rock drill on right.

erture open to the direct action of the
iter, against which the compressed air
could be no protection.
Early in 1903, when under the middle
the river, with seventy-five feet of
ater overhead, the shield in the first
the New York & New Jersey Com-
ny's tunnels encountered a ledge of
ck and was injured. The work was

earth, and the men were face to face with
the river. The seam was effectively
stopped up with bags of sawdust and
bags; but could the shield be moved
ahead the full remaining distance till the
permanent lining could be forced in be-
hind it?
